WATER FOR LIFE ASSESSMENT

Nicaragua  
July 2014

Organizational Evaluation of  
El Porvenir  
“Clean water, Healthy Communities”

July 12, 2014

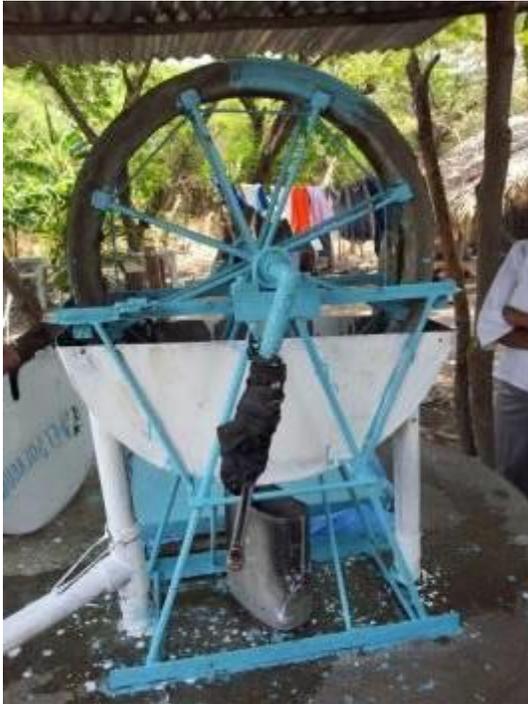
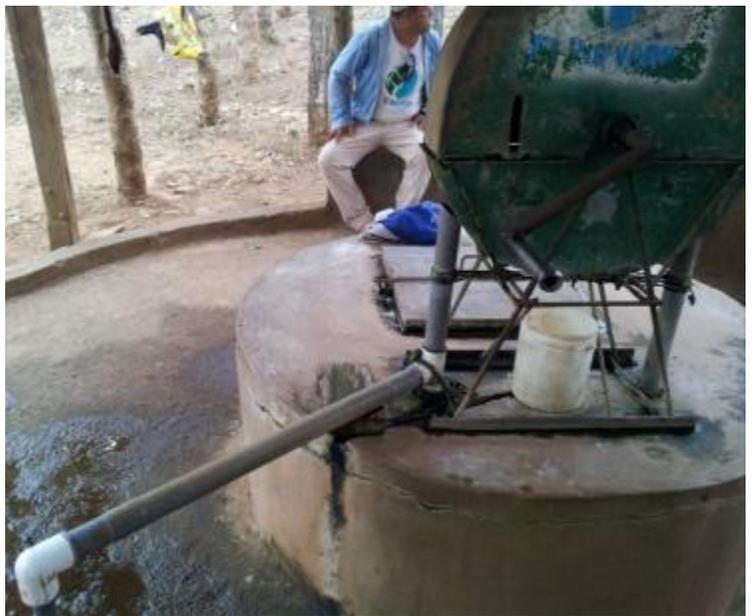
*Figura 1. Hand-dug wells with rope pumps*

Water systems from EP are: gravity-fed piped systems (MAG) or pumped piped water (MABE), hand-dug wells with rope pumps, drilled wells and hand-washing stations in schools and collective laundries. **Figure 1** shows hand-dug wells. Sanitation is provided by scholar toilets, sand bio-filters and family double pit latrines –latrines were built with single pit before-.

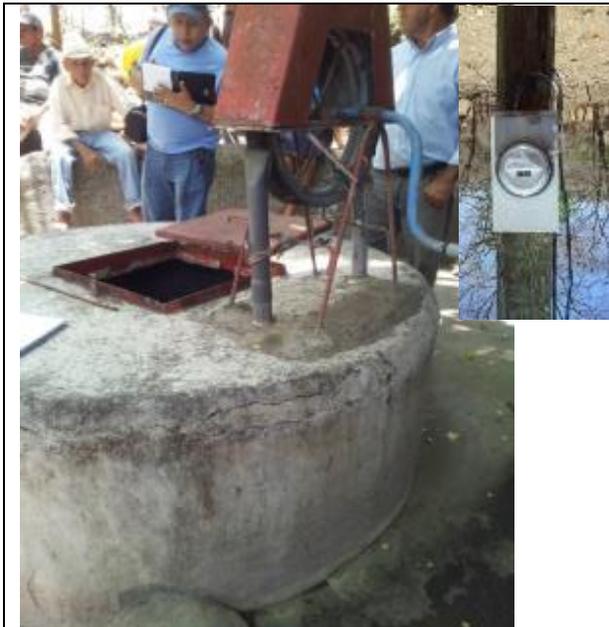
Pumping operates two to three hours a day during early morning (5 to 8 am) to fill the storage tank. It has an altitude valve to control water filling and to avoid spillover.

**Well operated by electrical pumping**

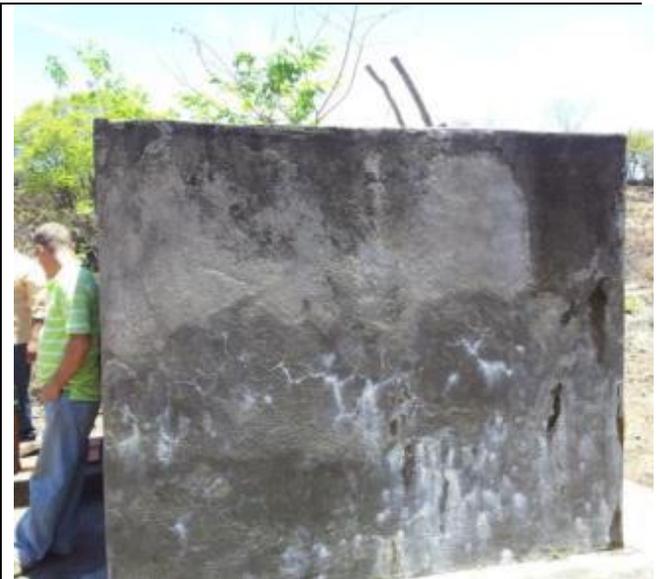
**Storage tank of 6 m3**

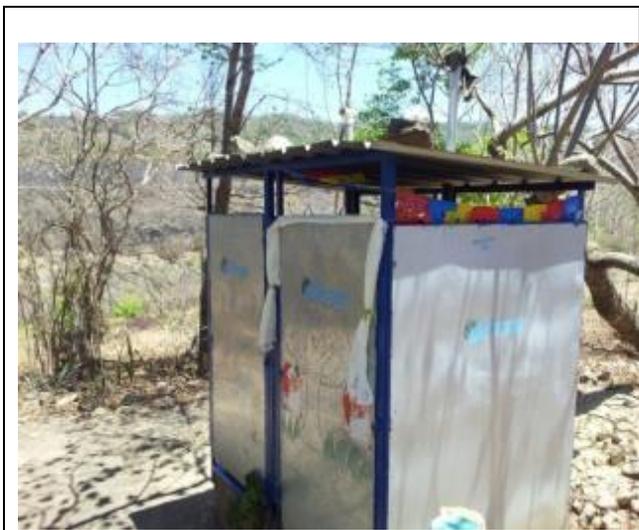
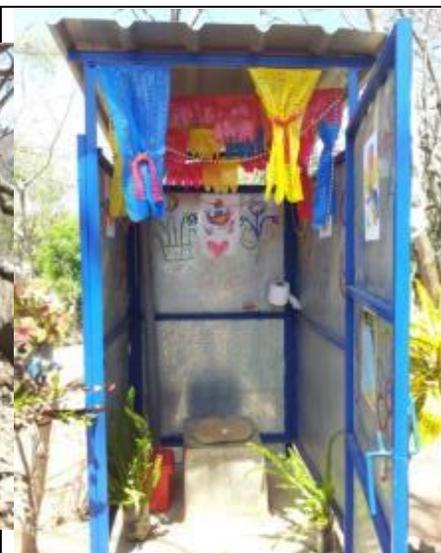
Community has single pit latrines in each of the households.

**Single pit latrine**

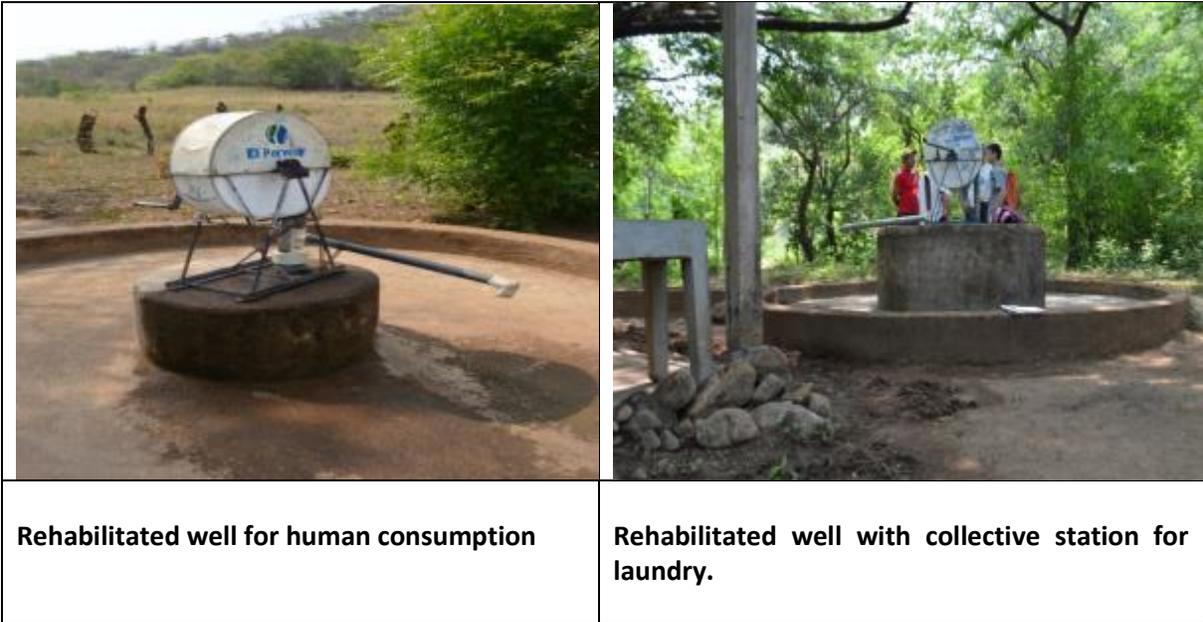
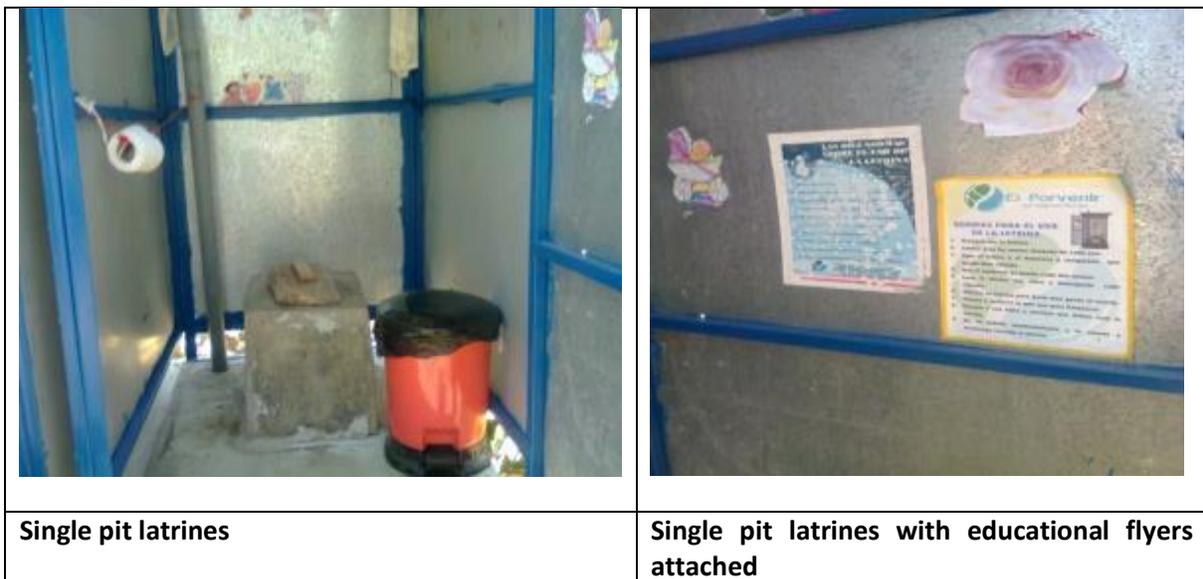
In this community EP has rehabilitated two hand-dug wells with rope pumps: one is used for human consumption and the second one has a collective laundry nearby.

This community is integrated by 27 households, 13 are supplied by the water well but there are latrines installed in 39 households covering the whole community and surroundings.

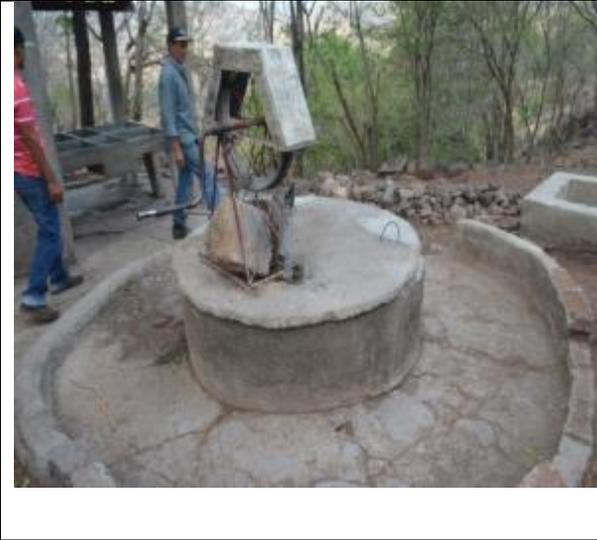
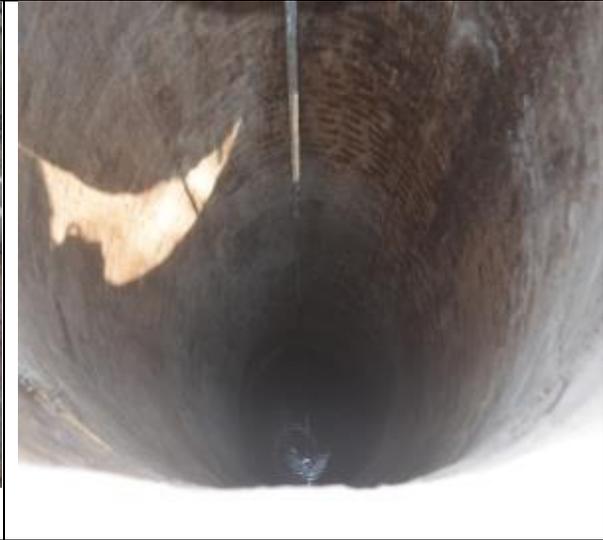
EP has rehabilitated two hand-dug wells with rope pumps and a collective station for laundry. Water for consumption is supplied by a new well drilled by Nuevo FISE with adequate chemical and bacteriological characteristics.

<p><b>hand-dug well with rope pump rehabilitated</b></p>	<p><b>hand-dug well rehabilitated</b></p>

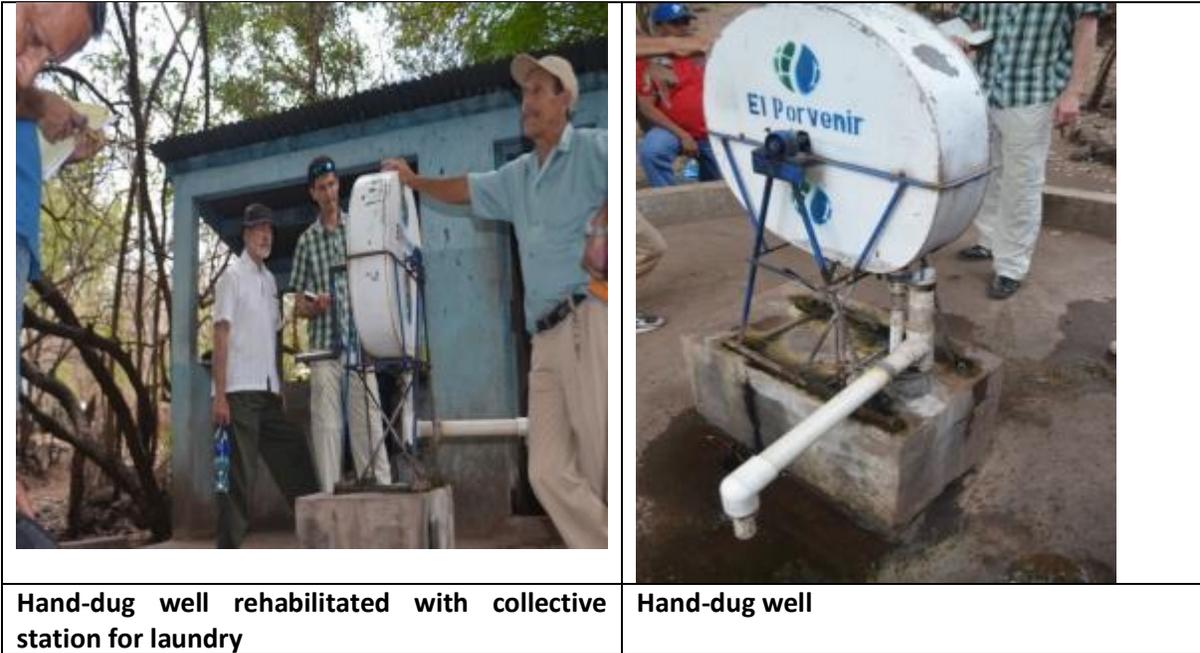
EP has rehabilitated hand-dug wells with rope pump, one is used for water consumption and the second has a collective station for laundry. La Pita sector with 20 households in Monte grande is supplied by the rehabilitated water well aforementioned and the community Cuajiniquil has an electrical system (MABE) who is eventually served by the water well from La Pita when an electrical cut is presented.

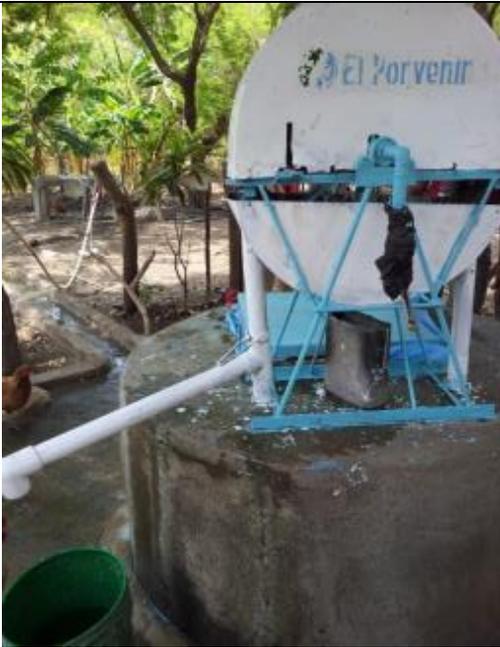
It is located in Boaco. It has a hand-dug well with rope pump which supplies to 26 households with approximately 130 persons. The water well is built in the middle of the community. Another hand-dug well is in the school but is no longer used for consumption due to sulfates presence in the water (smell as rotten egg) and possibly with presence of iron and manganese.

Hand-dug well with rope pump for consumption by the community

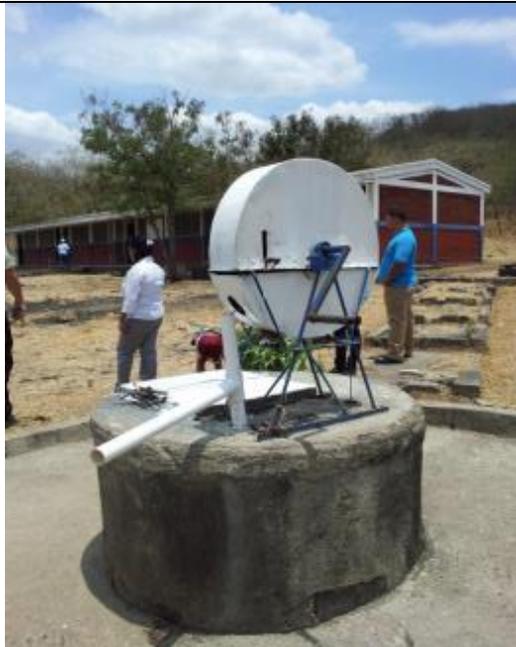
Hand-dug well with rope pump for use for laundry due to presence of sulfates.

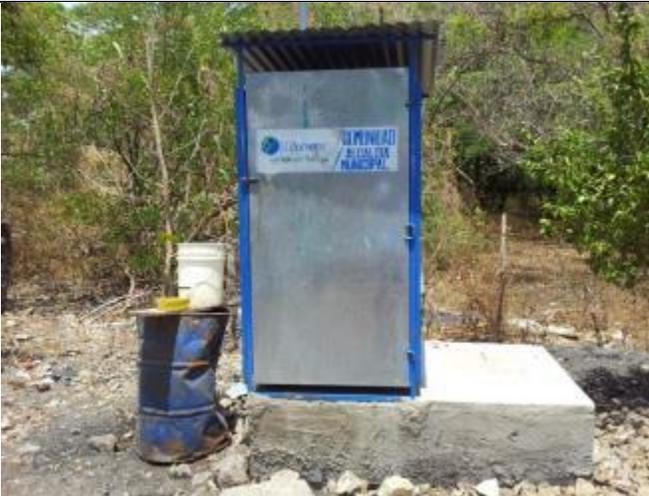
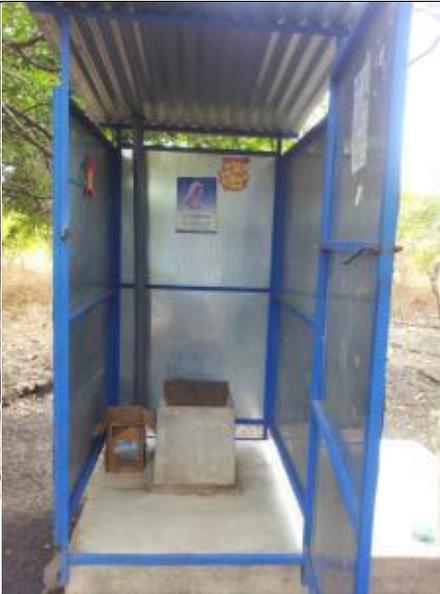
The community has double pit latrines in each of the households.

Double pit latrine

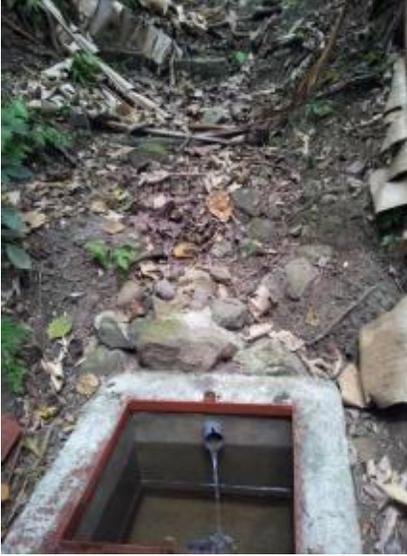
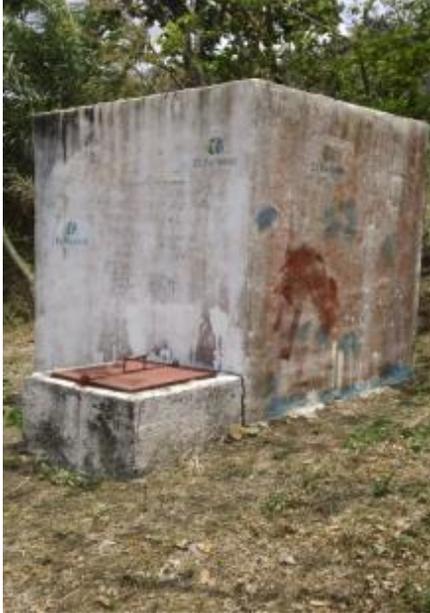
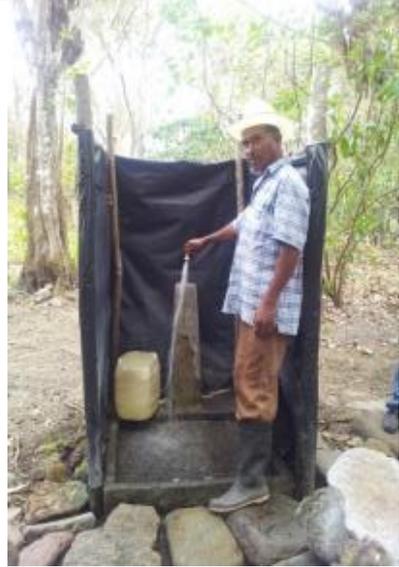
It is located in Boaco. Consists of a gravity-fed piped system from a water spring catchment. It has a storage tank of 5 m<sup>3</sup> and supplies water to 12 households in a scattered area. Discharge was measured 3 L/min and 2,6 L/min within two points nearby the water intake. For the community water discharge should be 5 L/min, which in turn requires water management during droughts.

<b>Water catchment</b>	<b>Storage tank</b>	<b>Water tap to use for two households</b>

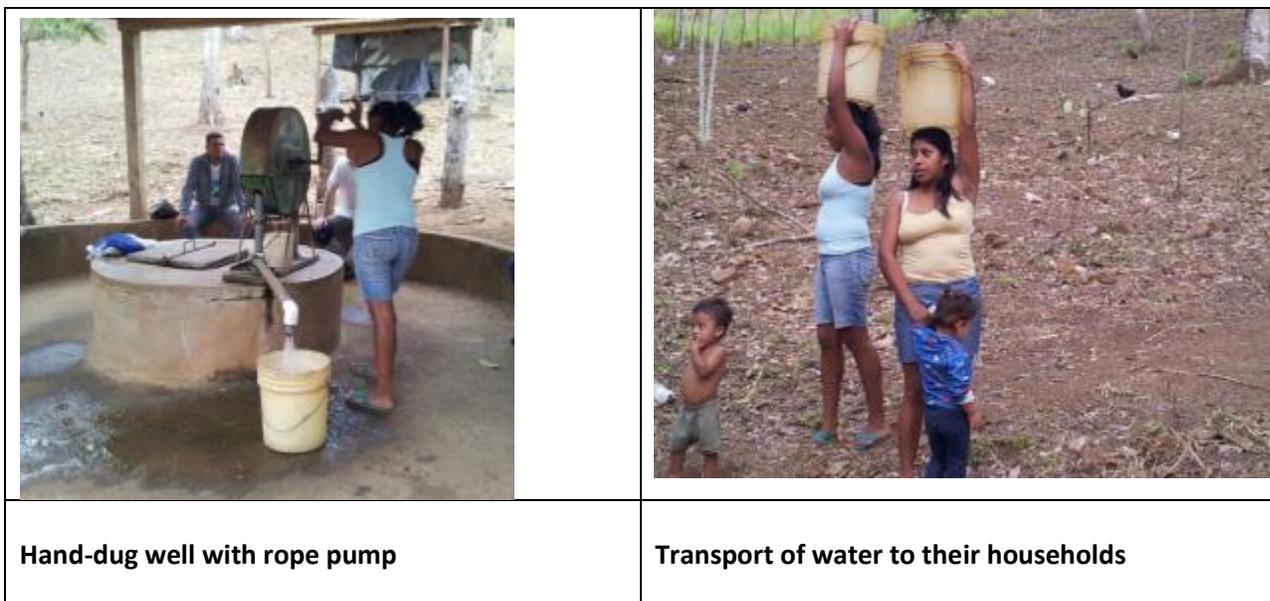
It is a small community who live inside private property (called “colonos”). The system consists of a hand-dug well with rope pump. Families transport water with buckets from the water well to their households around 5-10 minutes walking. The water well supplies to 7 households i.e. 50 people. There is no sanitation except a multiple latrine built by the owner of the private property.

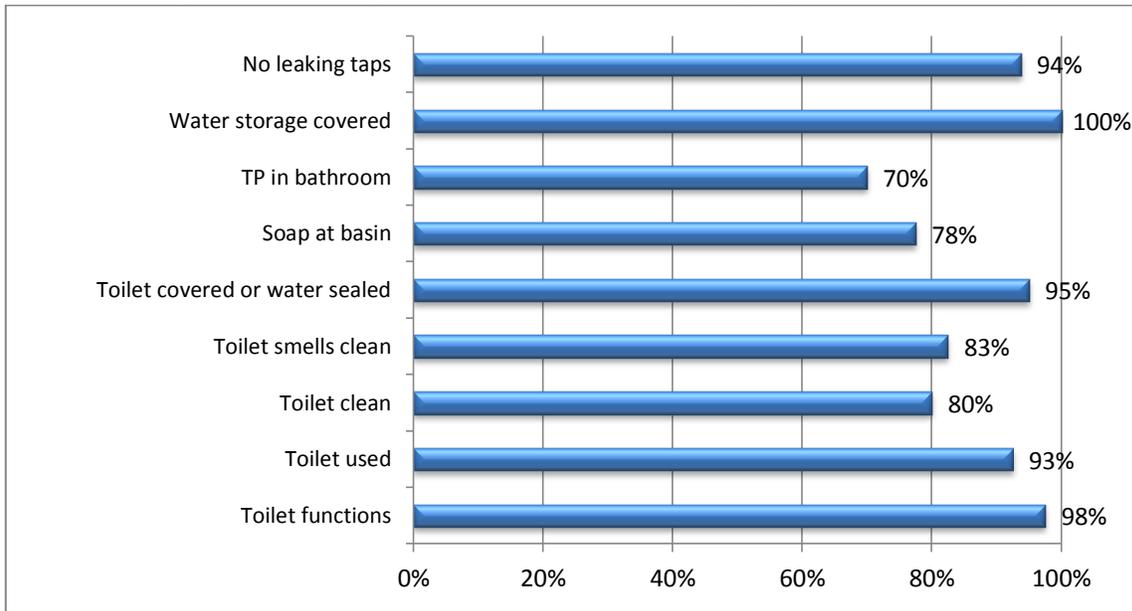
Figure 2. Results of Household Observation Surveys (includes La Ceibita)

Results from seven communities visited (including the exemplary community) include 40 inspections to households to evaluate hydraulic conditions at water taps and sanitation. **Annex 5** presents the observations from the independent evaluators and some of the participants. **Figure 2** presents a summary including La Ceibita and **Figure 3** excludes the results from this community.
